**North York Moors**  
National Park

# Conservation Area Character Appraisal and Management Plan

## Castleton

July 2023

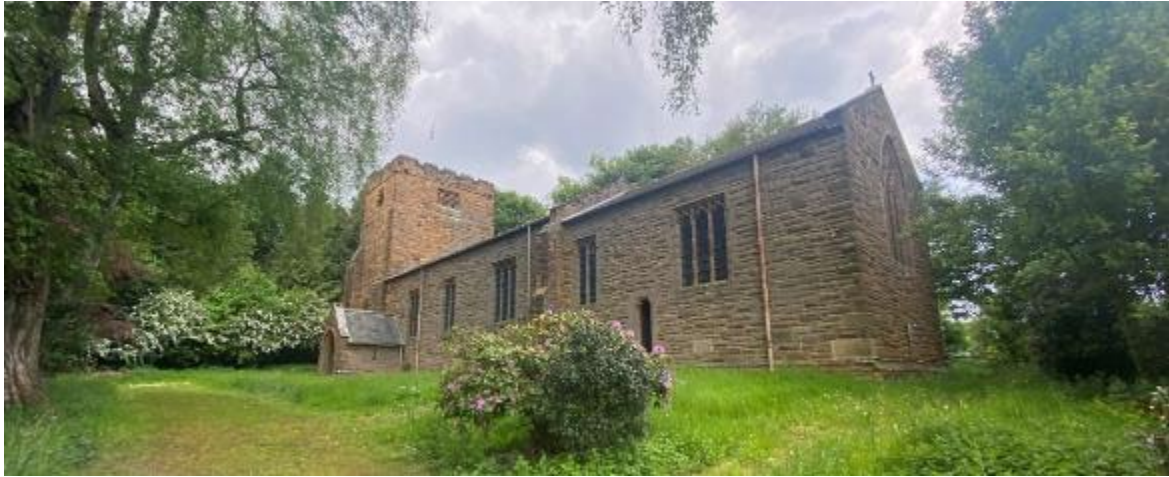
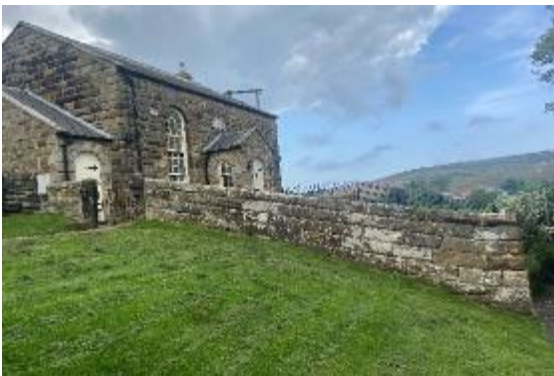
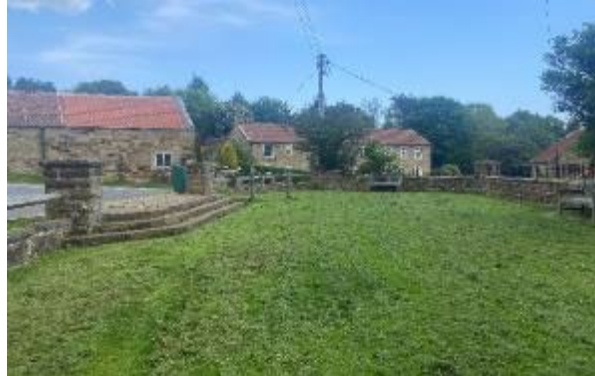
Figures 03-05. The church of St. Michael and St. George, former British Legion Hall and site of previous iron church, now green seating area.

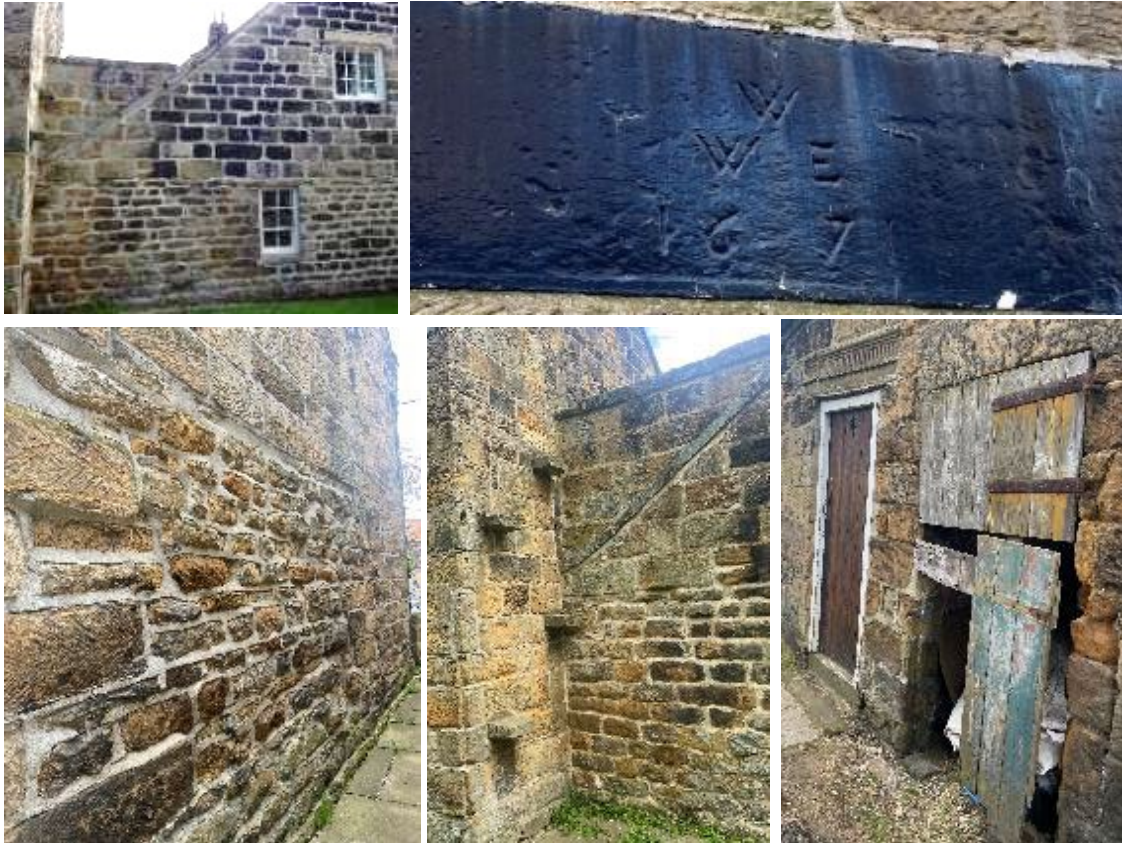
Several buildings show visible evidence of scarring from lost structures, blocked openings, and reused medieval masonry from the castle. There is also evidence of reused foundations in the form of large boulders at the foot of existing houses and buried remains resulting from previous activity. Internally, historic buildings may also have other features, often obscured by later plasterwork. Where a building appears 18th or 19th century in date, it may contain the hidden remains of a much earlier building. These scars resemble how buildings have altered over time to meet changing circumstances, such as the decline of the castle and the quarrying of its ruins to provide building materials. They can also represent the availability of new building materials made possible by the arrival of the railway in 1861 or changing fashion in design.

Figures 09-13: Images of scarring, previous openings, mason's marks and varied building materials. Materials may have been re-used from the castle, with variations in stone tooling.

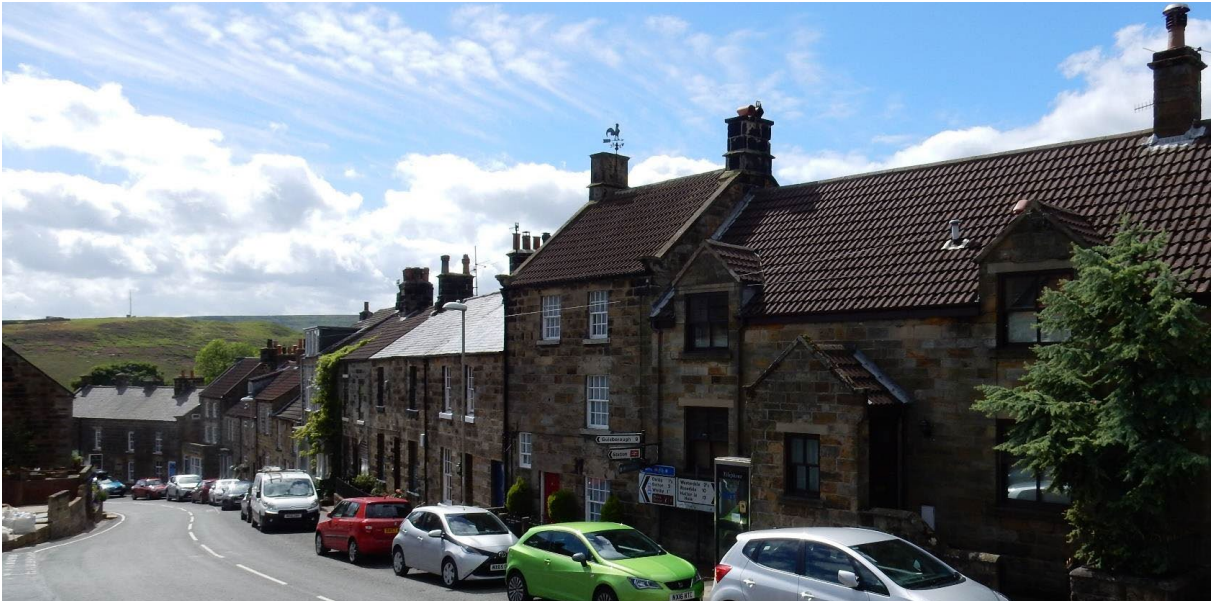
Figure 15: View down the High Street of Castleton, showing a gentle curve.

The High Street has a gentle curve to it. This may be to respect the medieval boundary of the castle prior to its demolition and suggests too that the castle complex was once much larger. The settlement pattern along the High Street is a standard medieval layout along a main road with linear plots extending backwards. On the south side these have been extended southwards in recent times, but the extensions are outside the Conservation Area. Modern houses north of the High Street and to the west have not always conformed to this street pattern.

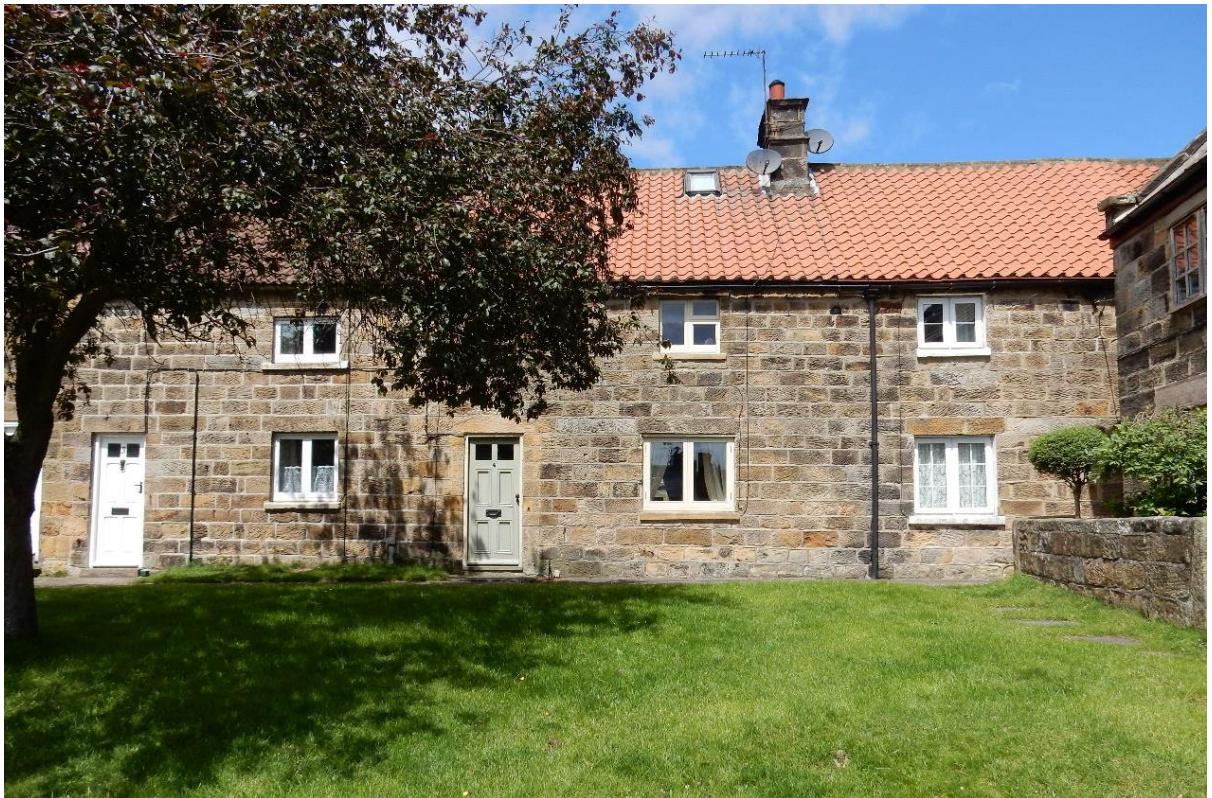
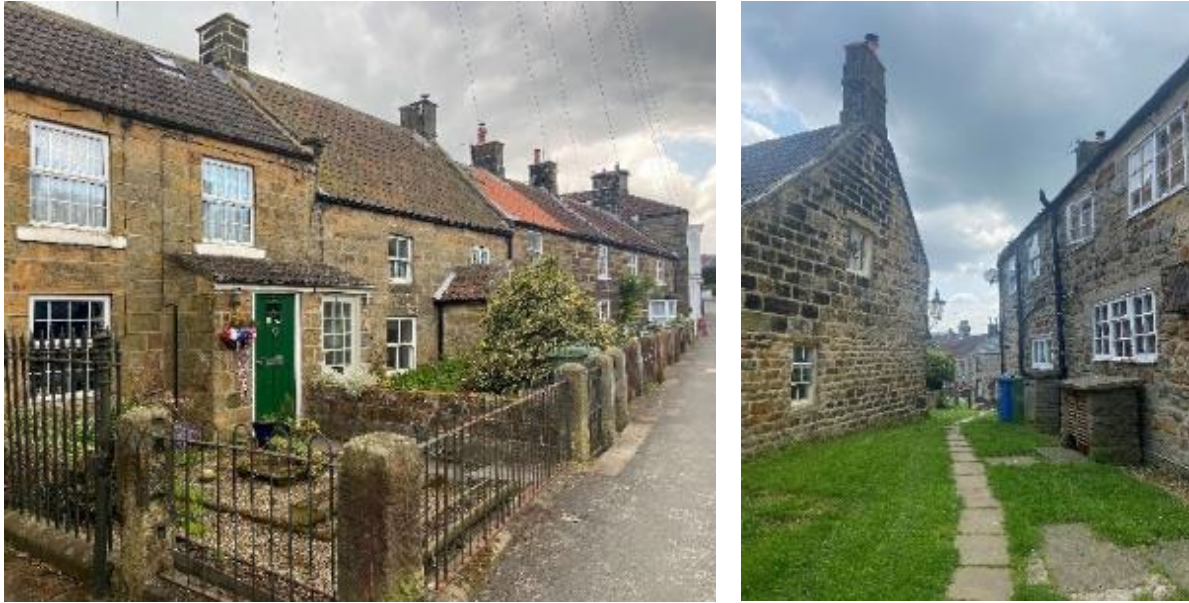
Figure 16-18: Stone cottages set on the street with some swathes of grass.

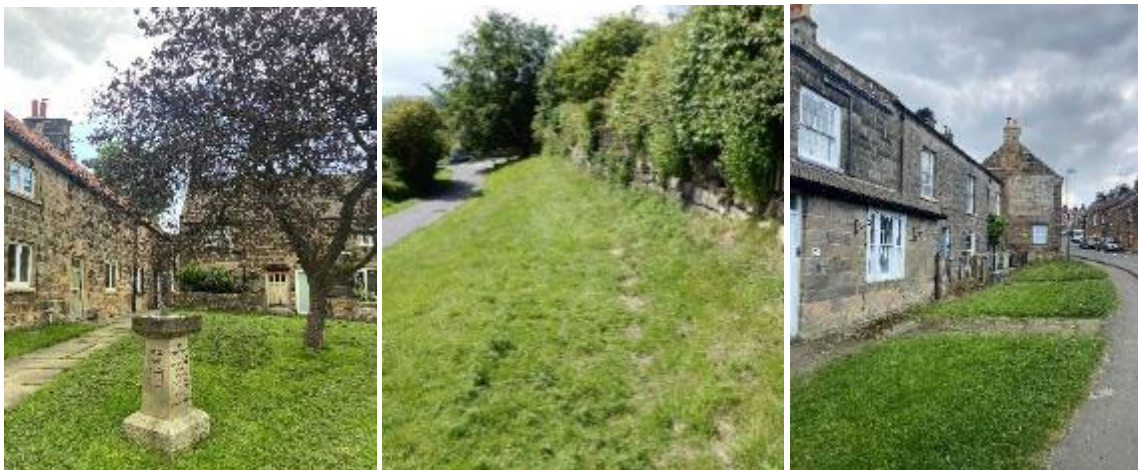
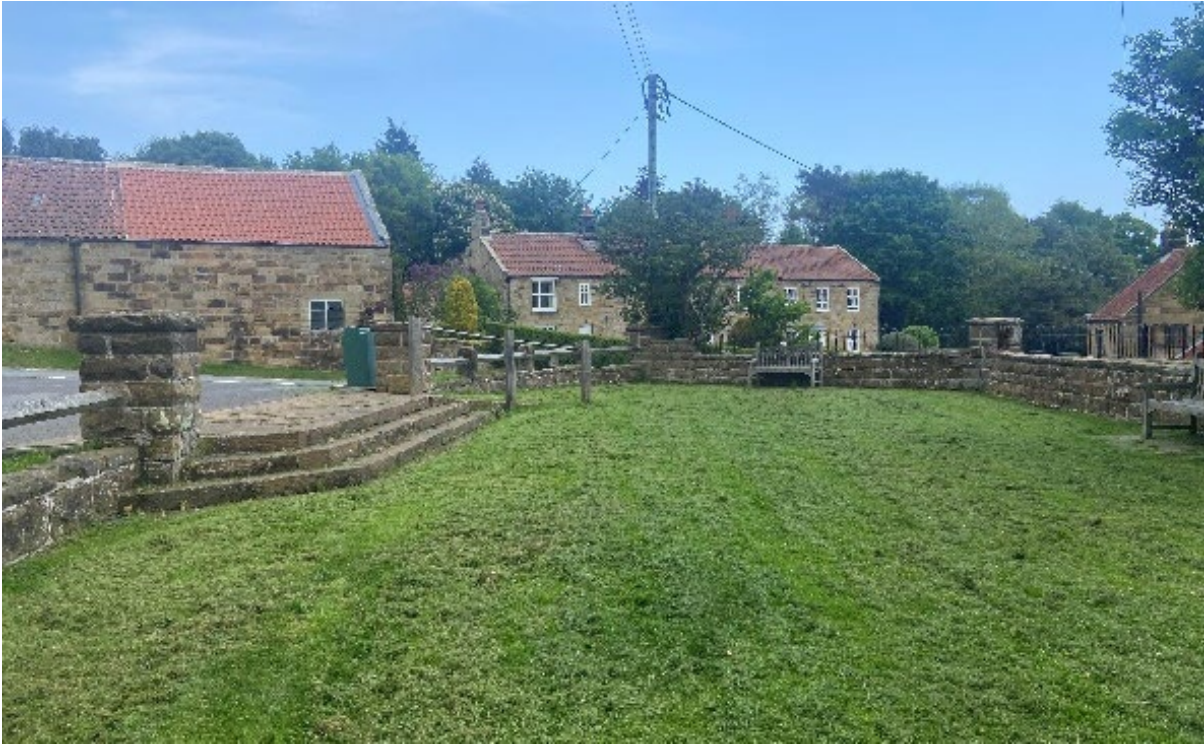
Figure 19-22: Examples of green spaces within Castleton

There are only a few open green spaces within the village, namely the grassy area on Primrose Hill (where the cheese fair was held) and the grassy swards that separate the houses here, the grass frontages to houses on the eastern lower parts of the High Street and the enclosure with seating at the east end of the village (the former chapel site). However, the village is surrounded by grassy fields leading down to the river and the former corn mill and these have been included in the Conservation Area, although the former mill buildings were excluded when the Conservation Area was first laid out.

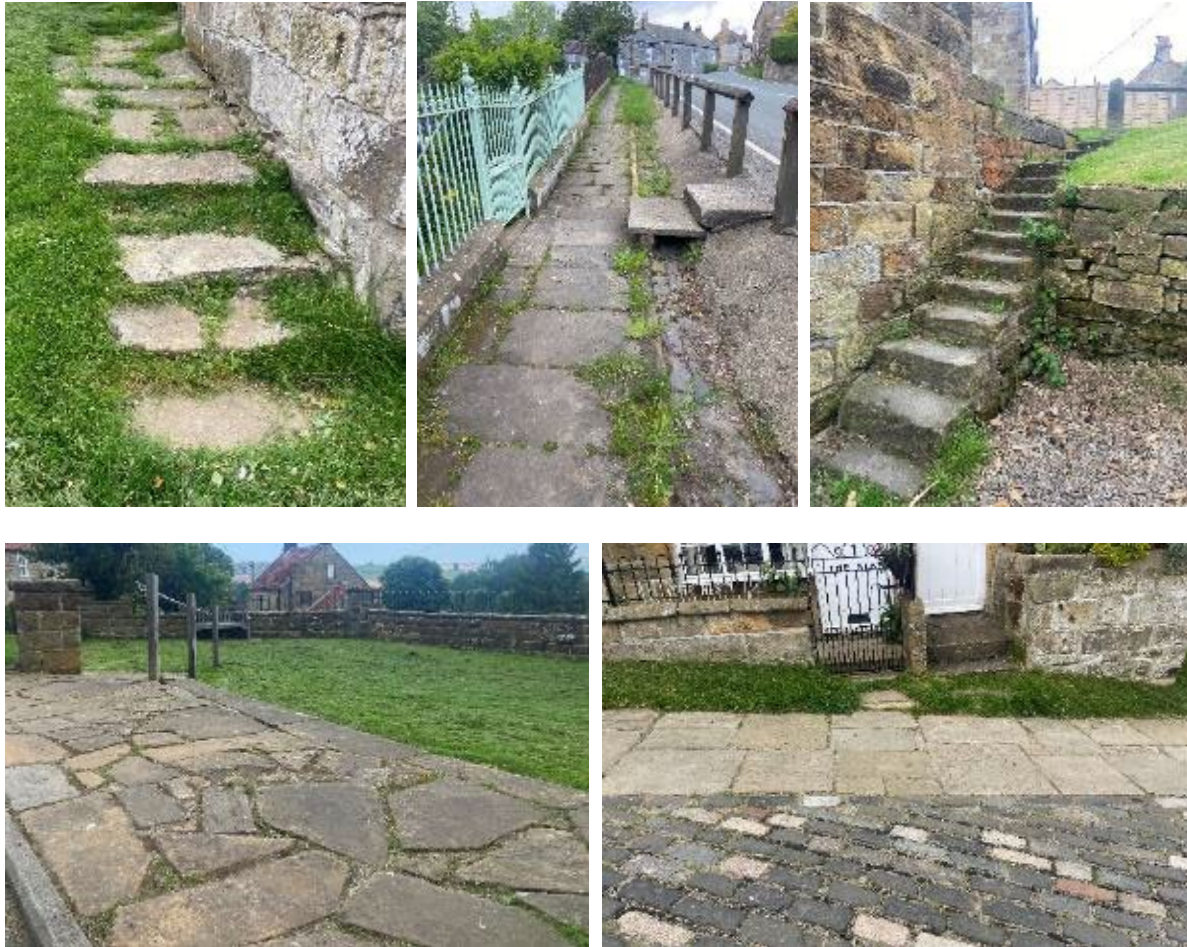
The only other surface treatments which have historic character are the stone flags outside the inn and on Primrose Hill and stone setts on parking areas on the High Street. Otherwise, tarmac predominates (especially on the Church Street - Ashfield Road junction), although the narrow strips of tarmac on Primrose Hill are overgrown by the grassy surrounds which soften its impact and allows the historic character to show through. Primrose Hill also has stone steps linking its high levels with the street below and these too have considerable historic character.

Figure 23-27: Examples of surface treatments including paving, steps, cobbles and trods.

- Consider traditional road surface materials on the Clapper Bridge (the bridge also requires urgent repairs).
- The three identified trees should have additional protection through a Tree Preservation Order (see figure 13 below).

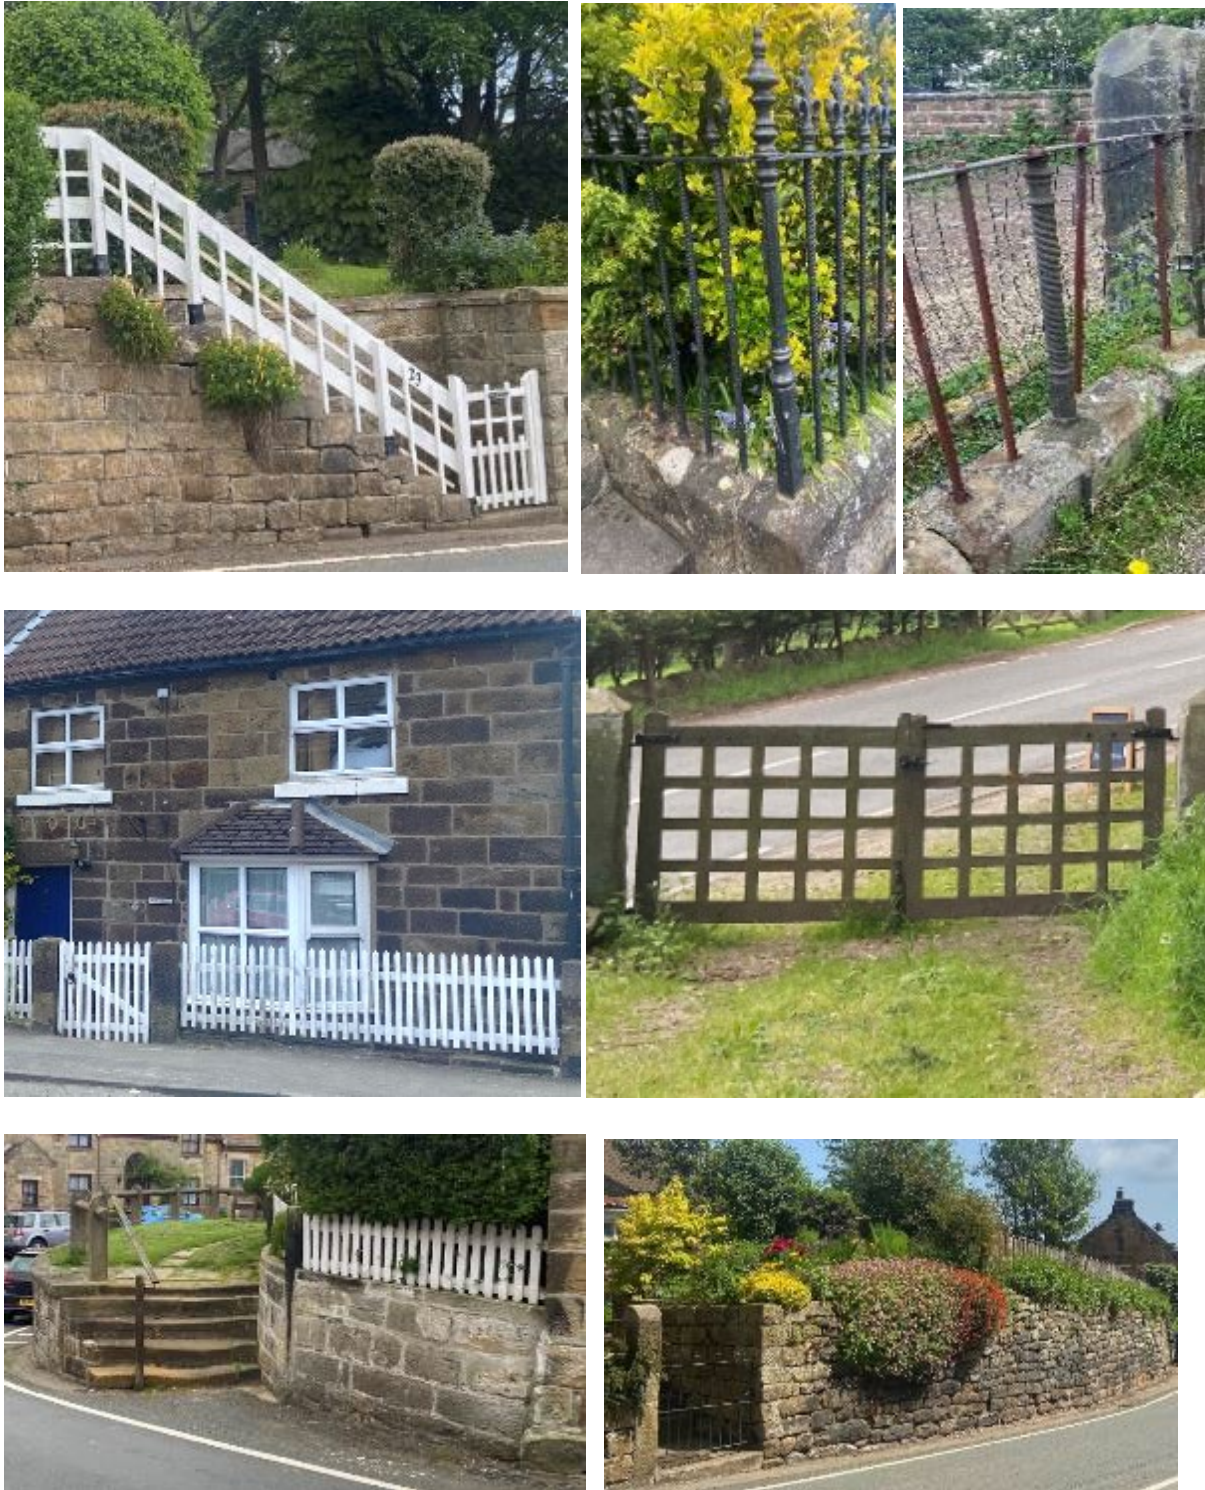
Figure 32-38: A variety of boundaries in Castleton, including stone, timber fences, stone steps, iron railings and gates.

Retaining walls along the roads are distinctive, usually of dressed stonework, often topped with vegetation and interrupted by field gates with stone gateposts. There is a mixture of drystone and mortared walls, but generally drystone is used for a boundary to a field. The boundary of Castle Hills to Station Road appears to have a ha-ha type wall topped with a later yew hedge. Prior to it being planted it must have protected views from the buildings on top of Castle Hills in the 18th century across the valley to the north, while keeping stock out of the gardens. Alternatively, it may have been a pragmatic

- Retain grass swards to house frontages and resist attempts to pave over.
- Expose stone trods as historic features along Ashfield Road to the mill.
- Retain iron railings and seek to replace any lost during the war.

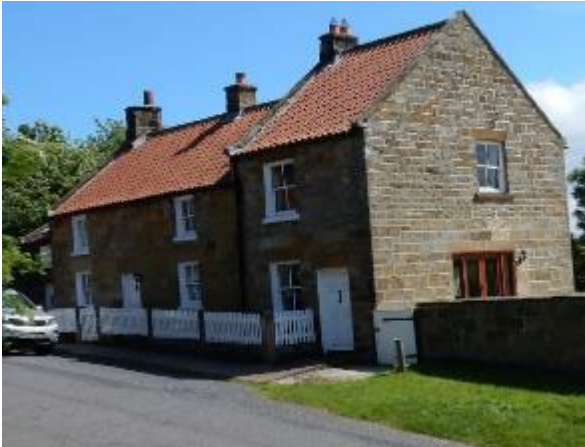
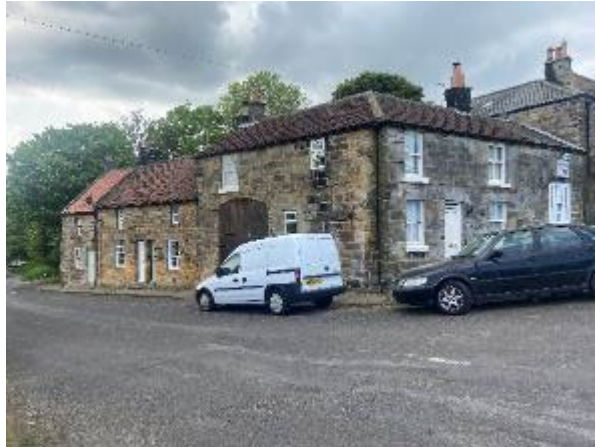
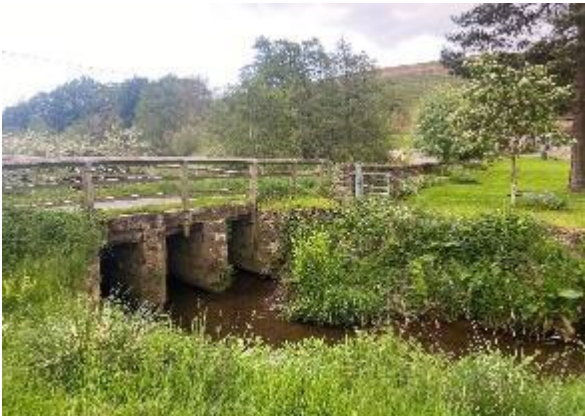
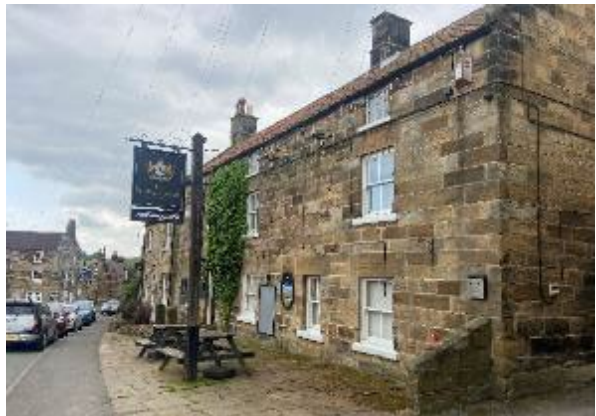
Figures 45-48: Some of the listed buildings in Castleton – Left to right: The Clapper Bridge, Downe Arms public house, Cottage on Ashfield Road and 5 Ashfield Road.

The public house, the Downe Arms, is more representative of the architectural and historic interest on the Conservation Area. This too is Listed Grade II and is an early 19th century style retaining its late Georgian two and a half storey appearance but with later four pane windows to the ground and first floors. Similarly, no's 11 and 13 High Street represent a typical 18th century house, now subdivided, with characteristic red pantile roof, stone kneelers and water tabling and chimney stacks.

The row of cottages, the wall and outbuildings on the corner of Ashfield Road and the High Street occupy an important position at the crossroads and therefore make a strong contribution towards the historic character of the village. Again, the pantile roof with stone ridge, copings, kneelers and stacks, combined with coursed herringbone tooled sandstone reinforces the historic character of the village. In much the same way, Ivy House and Ivy Cottage on the opposite side of the road, also convey a strong Georgian character and an agricultural one as Ivy House is a former farmhouse. The little pigsty further down Ashfield Road is a delight and should be considered as part of the curtilage of these listed buildings.

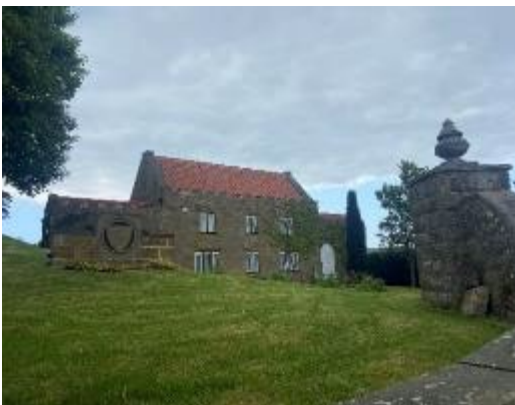
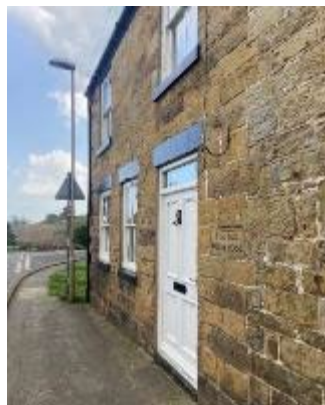
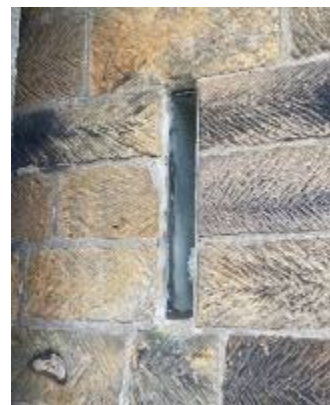
Figures 49-51: Local buildings on interest, previously Old Robin Hood and Little John Inn (said to be the last meeting place of Robin Hood and Little John) with slit situated next to the original fireplace. Castle site.

The earliest building in Castleton is the castle, although little survives of any buildings. Originally a timber structure, it was replaced in stone in the 12th century. This was largely demolished in the 14<sup>th</sup> century and the stone reused. Some sources suggest that the stone was reused to build Danby Castle which replaced it, but the ruins were possibly quarried again to provide stone for the church in the 1920s and decorated medieval stonework can be found in the buildings on Primrose Hill.

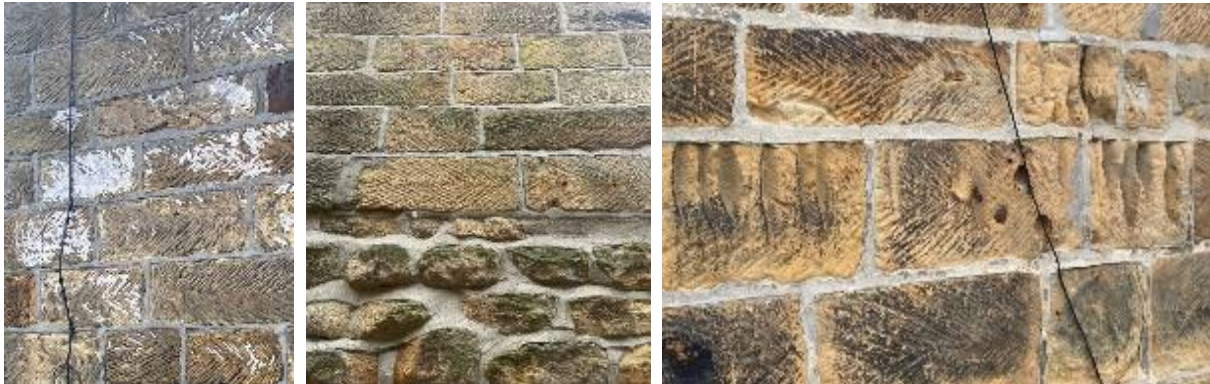
Herringbone, geological features and ribbon pointing:

Local sandstone remains the predominant building material; the surrounding area has a number of small sandstone quarries which have produced stone for building since the 11th century<sup>11</sup>. Much of the stonework is worn with age, some herringbone pattern survives, and geological anomalies also create interesting grooves in some ashlar blocks caused by water erosion. The mid-20th century appears to have favoured ribbon pointing between ashlar blocks and this is now resulting in damage to the sandstone.

Figures 53-55: A variety of tooling styles and possibility of surface finishes.

- Cast iron rainwater goods should be retained or replaced with like for like materials when defective.
- Information on appropriate pointing materials and styles will help homeowners protect the building fabric from damage.

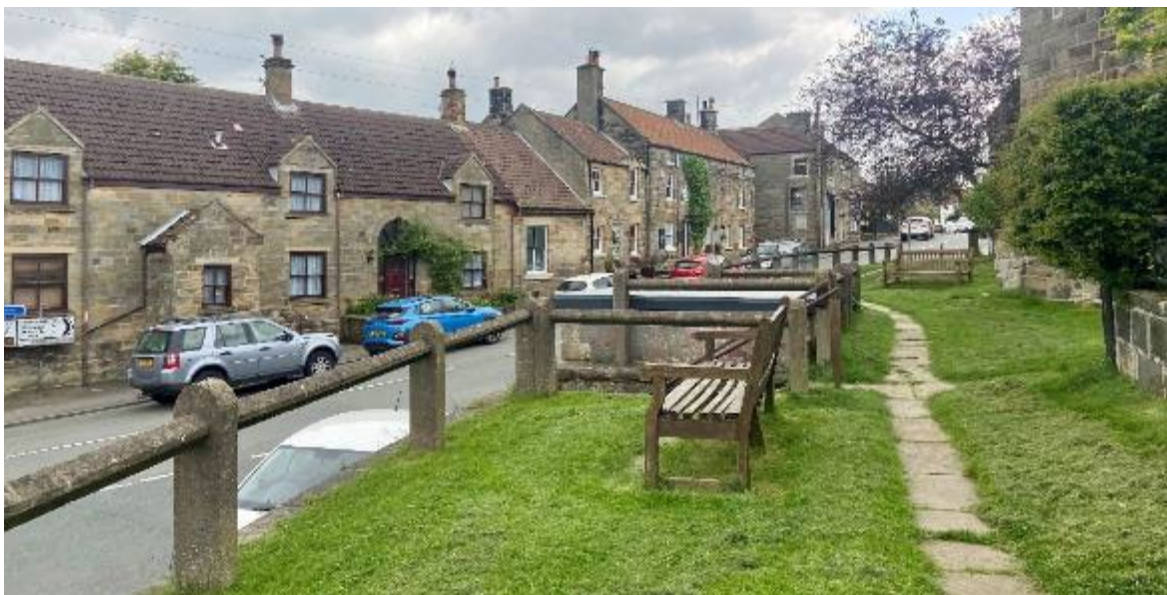
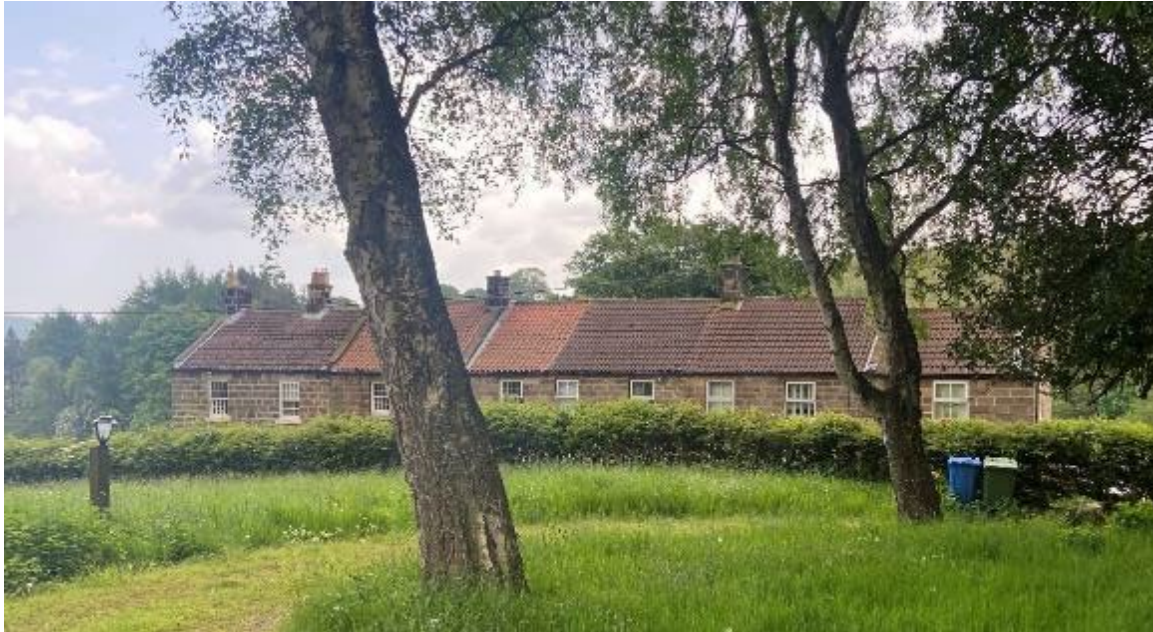
Thatch was the traditional roofing material and was made from rye, or wheat straw in this area, although heather from the moors may also have been used. (The severed hand, known popularly as the Danby Hand of Glory, was found hidden in a wall of the thatched attic in Hawthorn Cottage on the High Street in Castleton in 1935, so thatch appears to have survived into the early 20th century.) The steep pitch of the mill (outside the Conservation Area) is suggestive of a formerly thatched roof and there are steep pitches surviving at Primrose hill too. Today the buildings use red pantile (or modern equivalents) or imported Welsh slate as a roofing material. Red pantile was introduced from about 1740 when they were imported from northern ports into Whitby but local tileries soon became established near Whitby and Pickering and carried along Eskdale and its tributary dales<sup>12</sup>. Eighteenth century buildings also use stone water tabling and kneelers on the gables; roofs are also adorned with chimney stacks to the ends and in some cases dormer windows and weathervanes.

Figures 56-57: Undulating roofscapes, pantiles, Welsh slate, water tabling, kneelers, chimney stacks, dormers, and a weathervane.

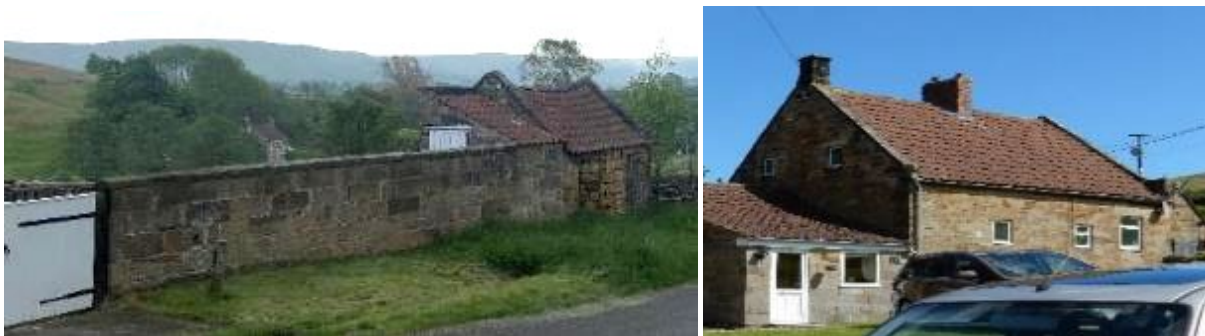
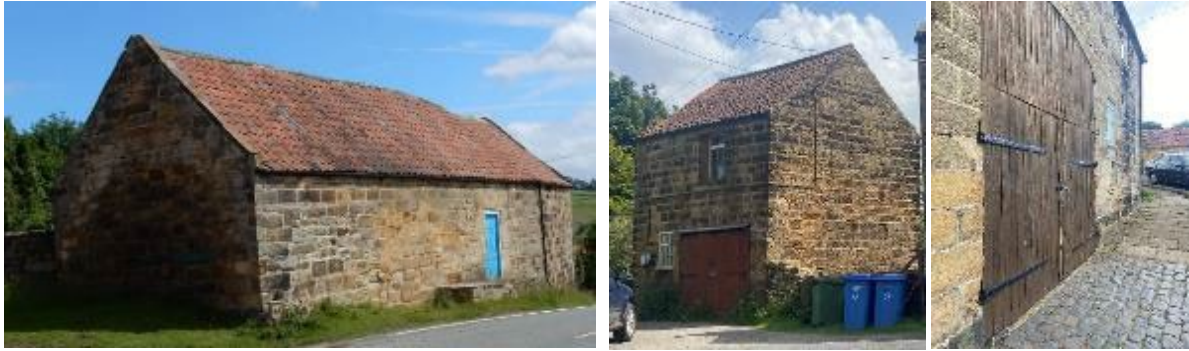
Figures 58-62: Examples of agricultural dwellings, outbuildings, and features.

From the middle of the 18th century onwards the old cruck built houses began to be replaced by two storied, modest sized, four square, Georgian style houses and it is from this period onwards that the present building character in the village is derived. Most farms groups were not planned, but evolved as circumstances changed, but Francis Mewburn of the Howe, just outside the Conservation Area, introduced a courtyard design towards the end of the 18th century. This design helped to make farming more efficient by grouping buildings and spaces together for maximum efficiency<sup>13</sup>. However, this character is not apparent within the village itself and is better appreciated outside the Conservation Area.

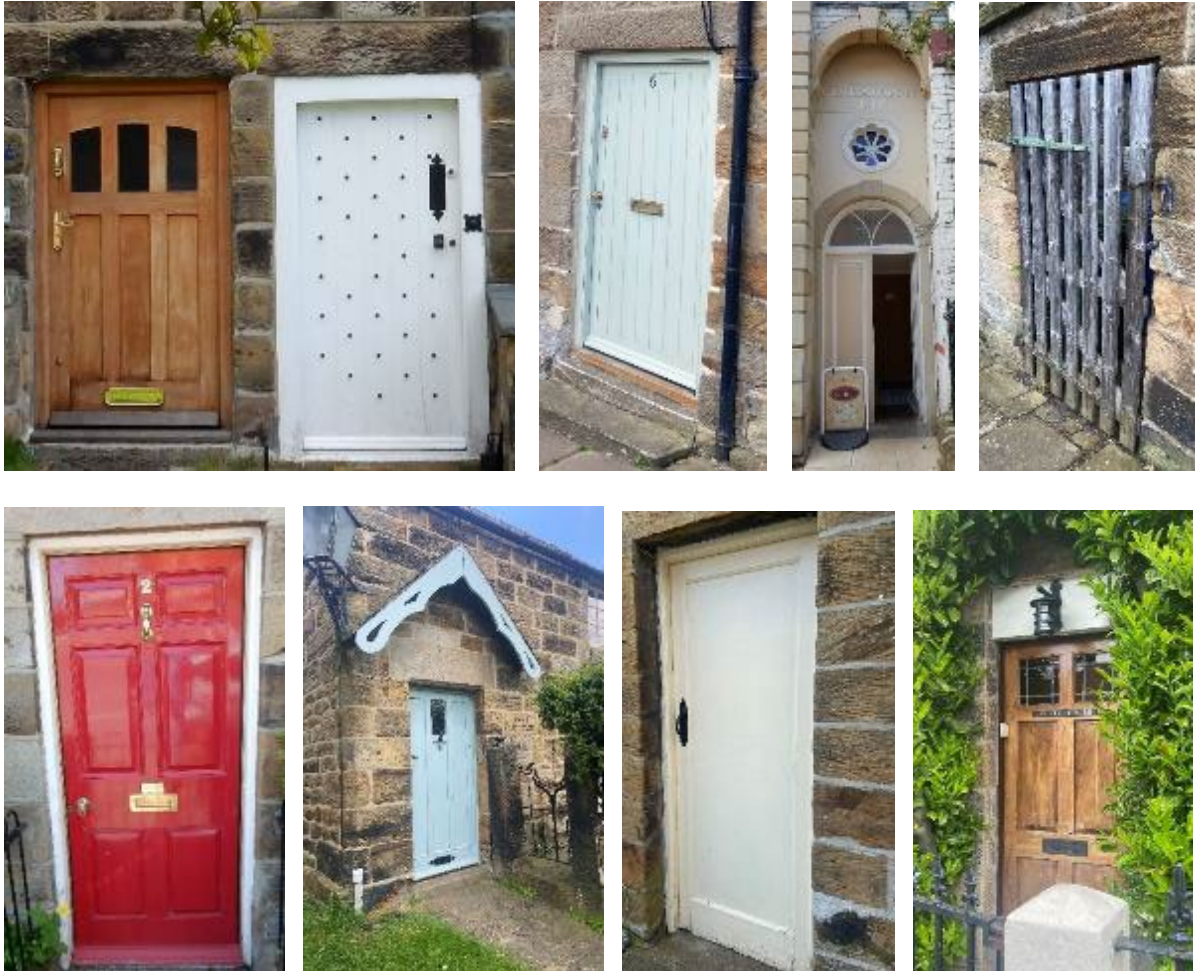
Most door types in the village are traditional cottagey doors, mostly batten and plank with some glazing on modern doors. There are a few Georgian style six panel doors and Victorian four panel doors with polished brass or iron furnishings. Porches are in evidence, but there may have been more in the recent past as scarring above some doorways show where structures have been fixed but have since been removed. Homeowners have displayed some sensitivity in choosing modern replacements that fit in well with the character of the village. Over lights and fan lights are not common but they can be found and appear to have been added to 18th century buildings.

Figures 63-70: A range of traditional doors within Castleton.

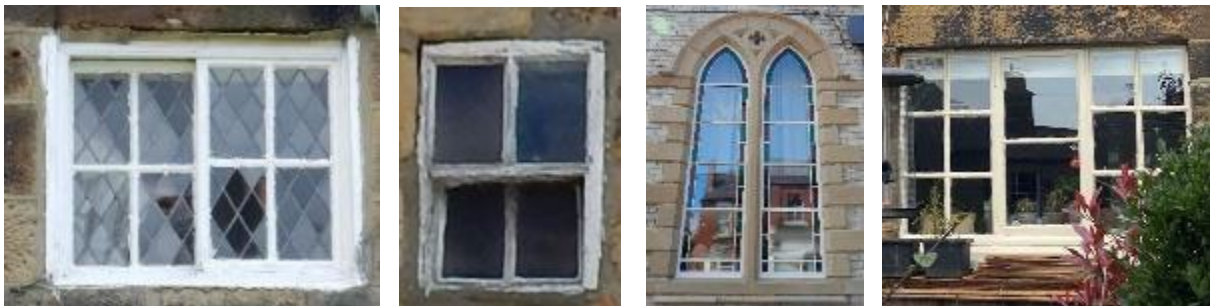
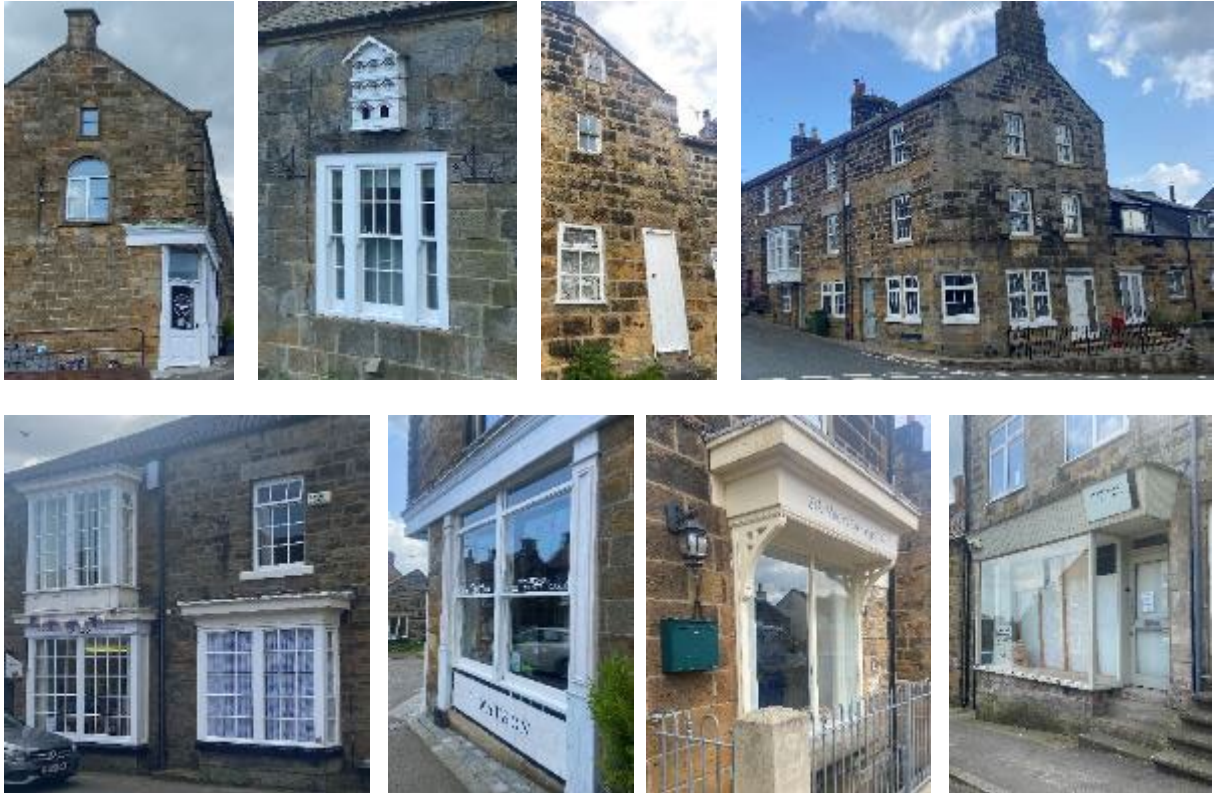
Traditional window types are to be found throughout the Conservation Area, although there have been some losses where plastic window replacements have been used. The traditional Yorkshire sash can be found including some leaded glass examples; the multi pane sash is much in evidence as is the Victorian four pane sash. There are a few shop windows including one on the High Street with an attractive stone bench running below the window.

Figures 71-82: A range of traditional windows and shopfronts in Castleton. A clear hierarchy of windows from ground to upper floor and a mix of modest and ornate styles and detailing.

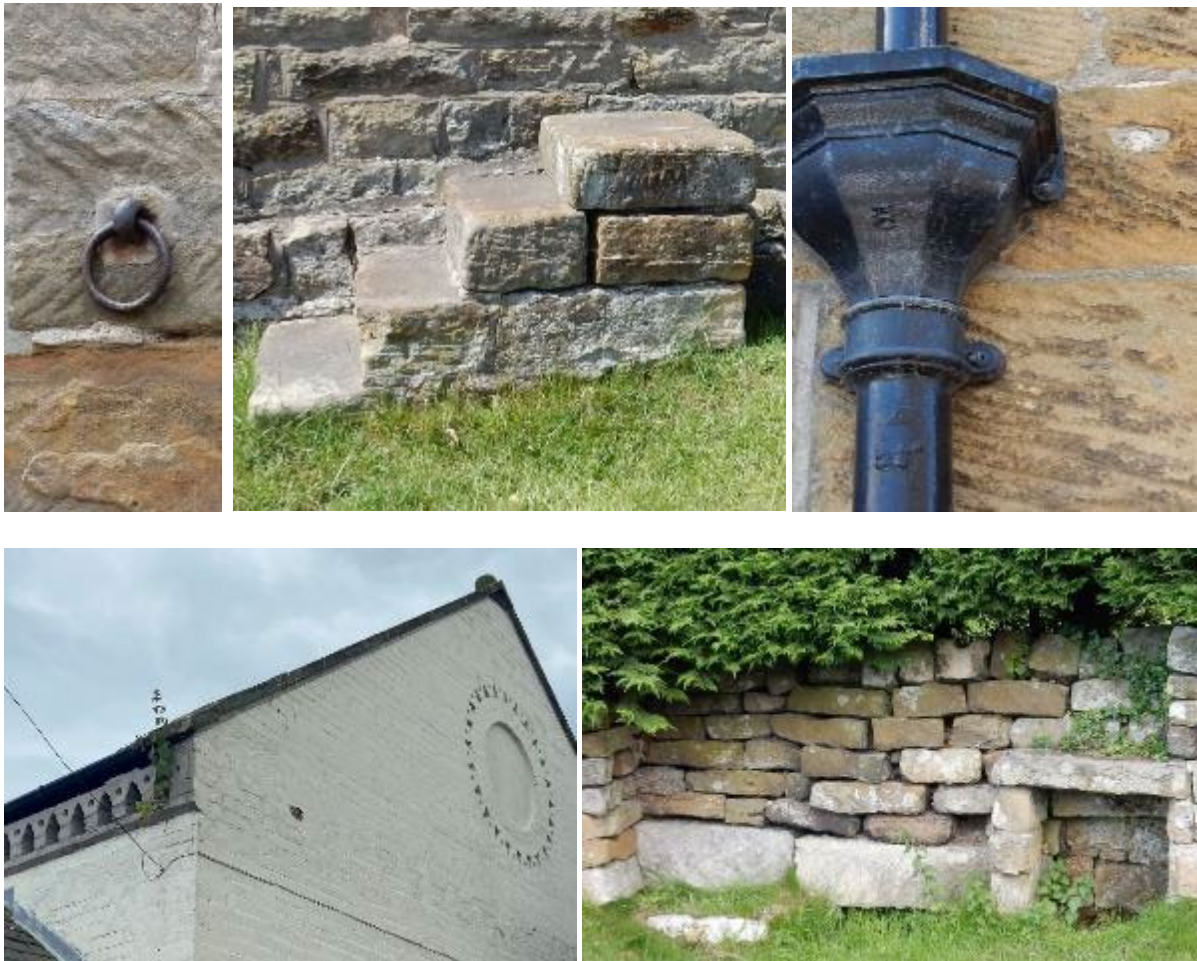
Figures 83-87: Small and often hidden details that positively contribute to the character of the area. Some included here are horse ties, stone mounting blocks, building details and cast-iron painted rainwater goods.

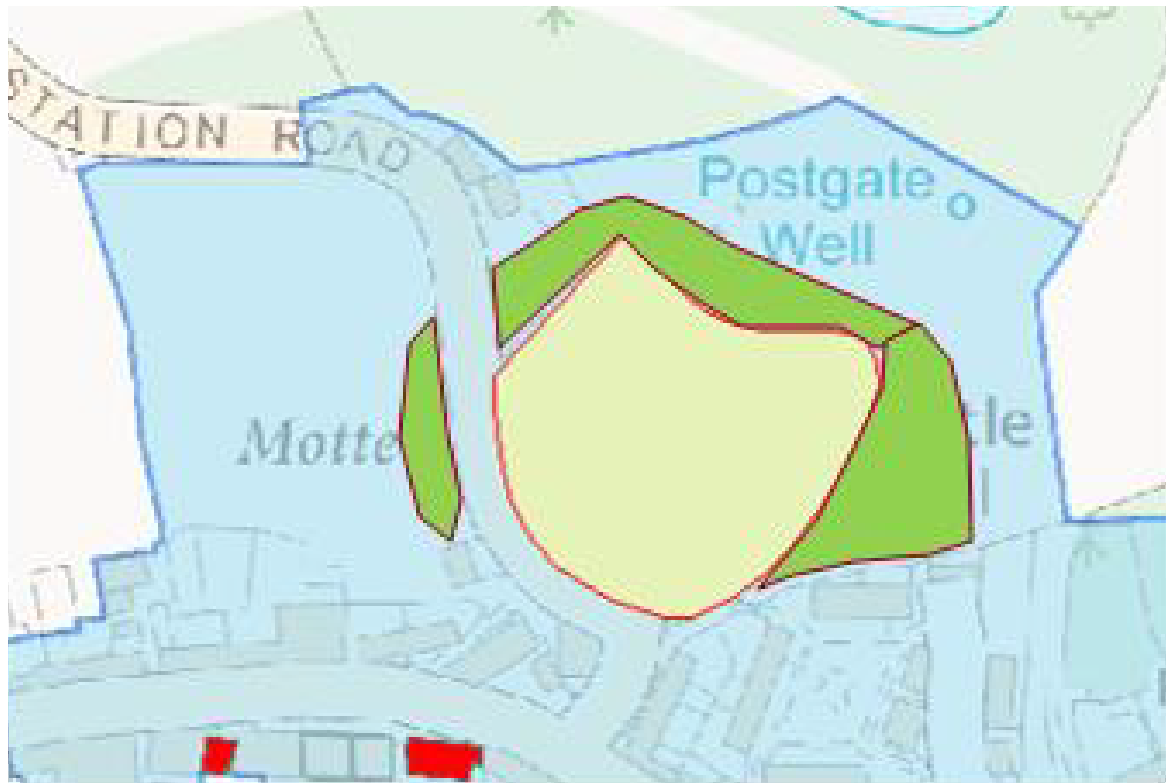
Figure 90: Proposed extension to the scheduled area to better reflect the archaeological potential of the castle remains (bright green with red outline).

- Developments within the Conservation Area may need to be informed by archaeological work and in some cases, further archaeological excavation carried out before or during development.
- Developments affecting historic buildings may need to be informed by a Statement of Significance.
- The designated area of the castle should be extended.
- The Conservation Area boundary should be extended to include the mill buildings, the mill leats and the stone trods leading to the mill (see above).
